Name Of Dam: SPORTSMEN'S CLUB DAM

Location: TAZEWELL COUNTY, VIRGINIA

Inventory Number: VA 18502

# PHASE I INSPECTION REPORT

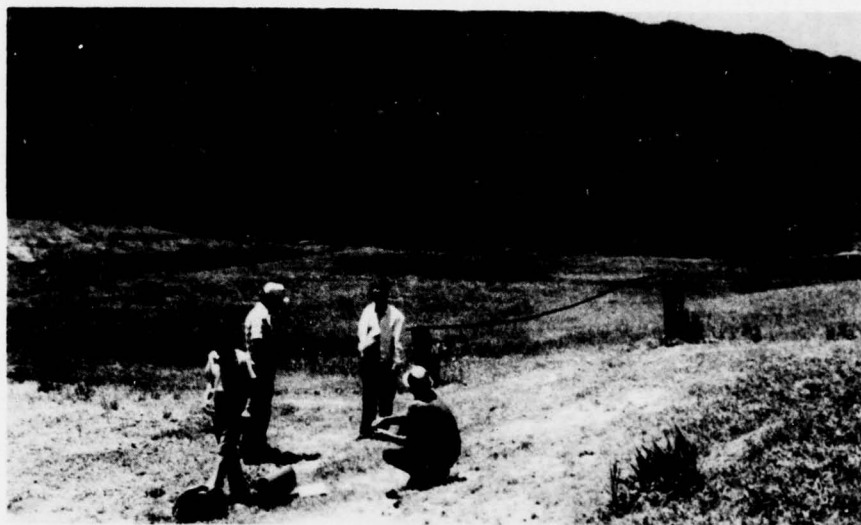
SADDLE AREA FORMING EMERGENCY SPILLWAY

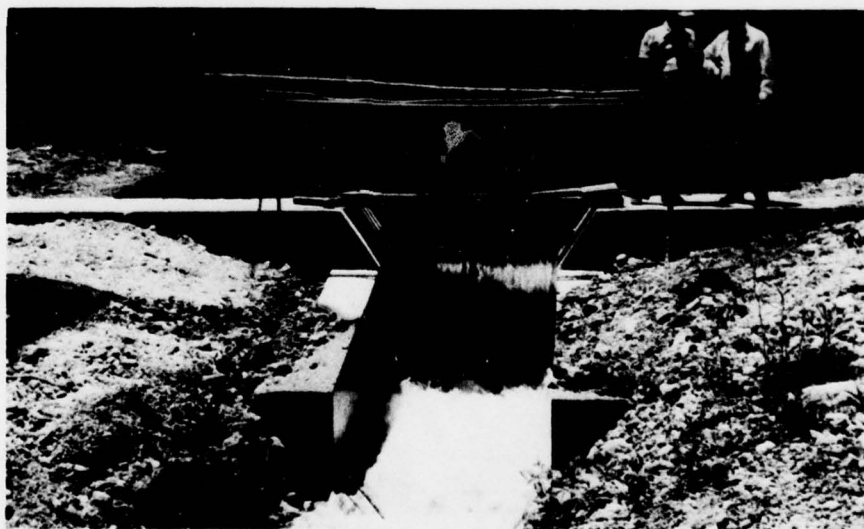
Some erosion of the sandy gravelly soil was observed at both the upstream and downstream corners of the concrete spillway. The downstream channel of the spillway consisted of weathered red shale. There was about 5 g.p.m. of leakage coming from the right abutment of the concrete spillway.

b. There are two eroded areas at the upstream edges and two eroded areas at the downstream edges of the recently constructed principal spillway.

c. There is about 5 g.p.m. leakage emerging at the top of the downstream right wall of the principal spillway. It is not critical under the normal-pool condition because of the low head of water at the location and gently sloping right abutment. However, during a flood condition, the leakage can seriously undermine the wall foundation.

PRINCIPAL SPILLWAY - NOTE LEAKAGE OVER WING WALL  
AT LEFT AND EROSION OF SOIL AT END OF BOTH WING WALLS

b. Eroded areas should be protected with adequately sized riprap.

c. The leakage at the spillway wall should be repaired.

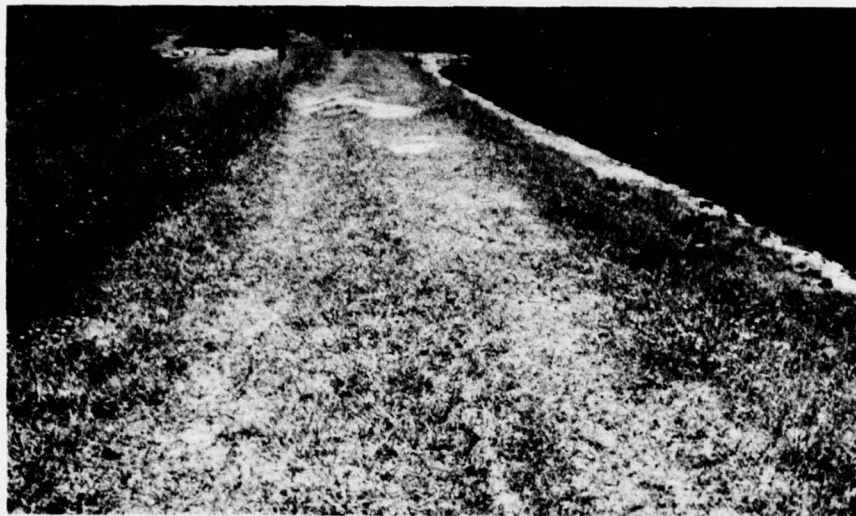
There is a fill area which is about 0.2 feet lower than the top of the concrete structure for the principal spillway between the principal spillway and the undisturbed shoreline.

a. There is an area of embankment about 0.2 feet lower than the top of the concrete for the adjacent principal spillway. In case of overtopping of the principal spillway, such a depression could result in concentrated erosion of the fill at that location.

CREST OF DAM - LOOKING TOWARD PRINCIPAL SPILLWAY

a. The embankment should be raised higher than the concrete top of the principal spillway, preferably at least as high as the emergency spillway and stabilized with grasses and riprap similar to the main embankment.
